Oxy-fuel furnace reliability reinforced by SEFPRO

SEFPRO CARE® REPAIR HOT BOTTOM: ENSURING CONTINUOUS PRODUCTION FOR OXY-FUEL CONTAINER GLASS FURNACES

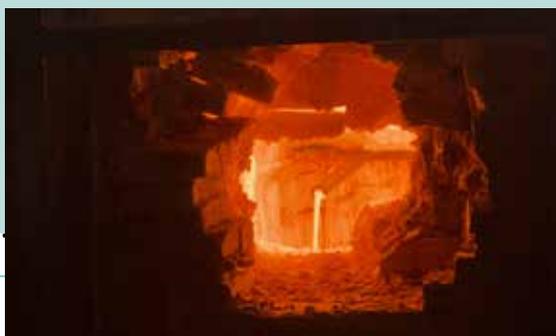
Selfflow and easily pumpable Repair Hot Bottom AZS installation.

The process began with a precise diagnosis using endoscopic inspection to identify the erosion and define a detailed technical plan. Preparations included draining molten glass, drilling the breast wall, and filling eroded areas with AZS crushed blocks. A customised injection lance was designed to match on-site conditions, and a screw pump trial run ensured flawless execution. This combination of technical rigour and rapid response exemplifies SEFPRO CARE®'s role as a trusted partner in maintaining furnace integrity without compromising production.

- Only five hours of injection
- Followed by twenty-three hours of sintering
- Allowing the furnace to restart in only 120 hours
